# **Manta Ray Viewing Boating Operations and Safety Assessment**

***Prepared for the Hawaii Coral Reef Initiative Research  
Program (HCRI-RP) on September 6th, 2015***

**by Marine Science Consulting LLC**

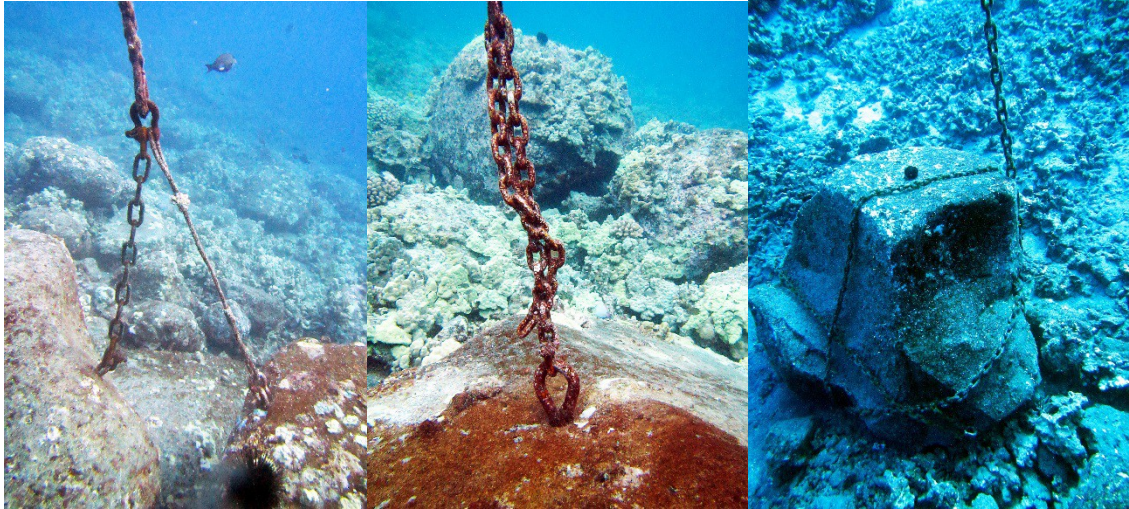
At Makako Bay, seven moorings with subsurface floats are used on a nightly basis (Figure 8, Table 1). Five are anchored using double pins, one (north inside) is anchored with a single pin, and one (north outside) is secured to a large boulder via chains (Figure 9). The north outside mooring is not a U.S. Army Corp of Engineers (USACE) permitted mooring. These moorings are located in close proximity and surround the circle of rocks known as the stone circle “campfire” where scuba divers place lights and sit on the seafloor to view manta rays (Figure 8). The campfire is the primary manta ray viewing site for scuba divers in Makako Bay.

Figure 9. Day-use moorings at Makako Bay: (left) middle outside with double pin anchor, (middle) north inside single pin anchor, and (right) north outside with chain anchor.

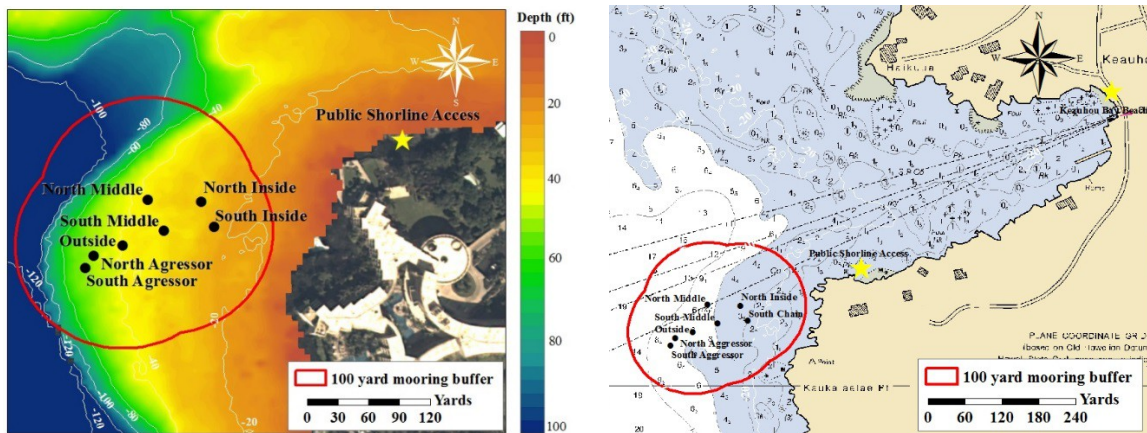
Figure 10. Map of the Keauhou Bay manta viewing site (left) and the day-use mooring locations– both official and unofficial. The red outline indicates the 100 yard perimeter surrounding the official day-use moorings and the yellow star indicates the location of the public shoreline access. The NOAA nautical chart (right) showing the Keauhou harbor boat channel and its proximity to the day-use moorings.

During the night-time observation periods, unrelated vessels exiting and entering the Keauhou harbor at high speed avoided the manta ray viewing area where most moored/anchored vessels were well lit. This behavior contrast to day-time activity when vessels commonly transit over the day-use moorings at high speed when entering & exiting the Keauhou boat harbor. However, on one night multiple groups of swimmers associated with lighted rafts were observed following manta rays well into the boat channel (north of the North Middle mooring) as defined by the NOAA nautical chart ([Figure 10](#)).

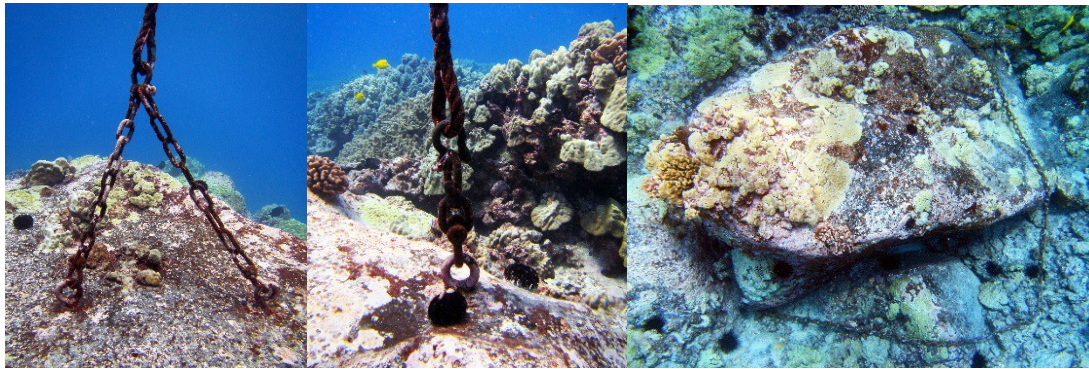
simultaneously. Compared to the Makako Bay site, the vessels at Keauhou Bay are less centralized and more dispersed along the shoreline and anchoring is much more frequent. While not assessed within the scope of this study, the live coral cover was observed to be quite high throughout the area where anchoring was observed. Damage to live coral colonies is likely unavoidable when anchoring in this area, especially at night.

Figure 11. Day-use moorings at Keauhou Bay: (*left*) middle south with double pin anchor, (*middle*) inside north with single pin anchor, and (*right*) south chain which is only loosely wrapped around a boulder.
