# **Manta Ray Viewing Boating Operations and Safety Assessment**

***Prepared for the Hawaii Coral Reef Initiative Research  
Program (HCRI-RP) on September 6th, 2015***

**by Marine Science Consulting LLC**

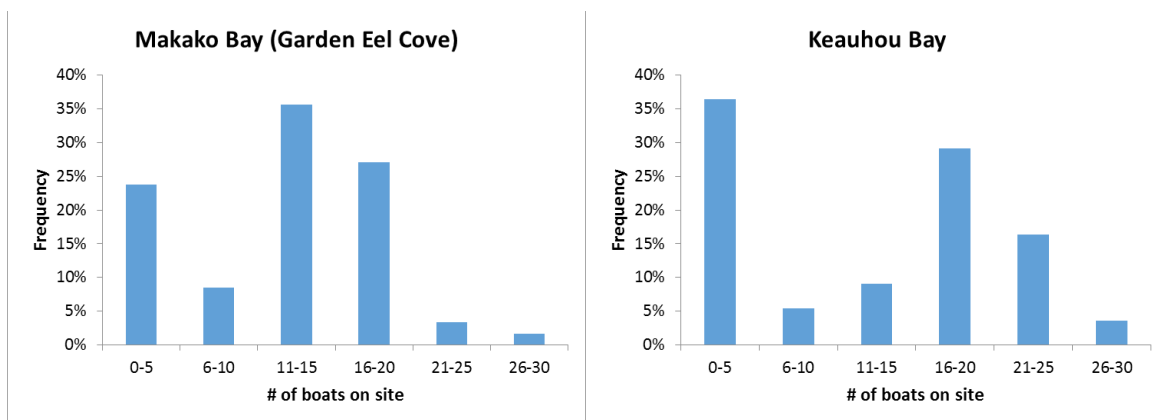
Figure 4. Frequency distribution of number of motorized vessels per night at each manta ray viewing site. Data derived from daily observation logs January-July 2015 from Manta Pacific Research Foundation. These data were collected from an operating vessel and therefore represent concurrent vessels on site. Total number of vessels visiting per night may be higher.

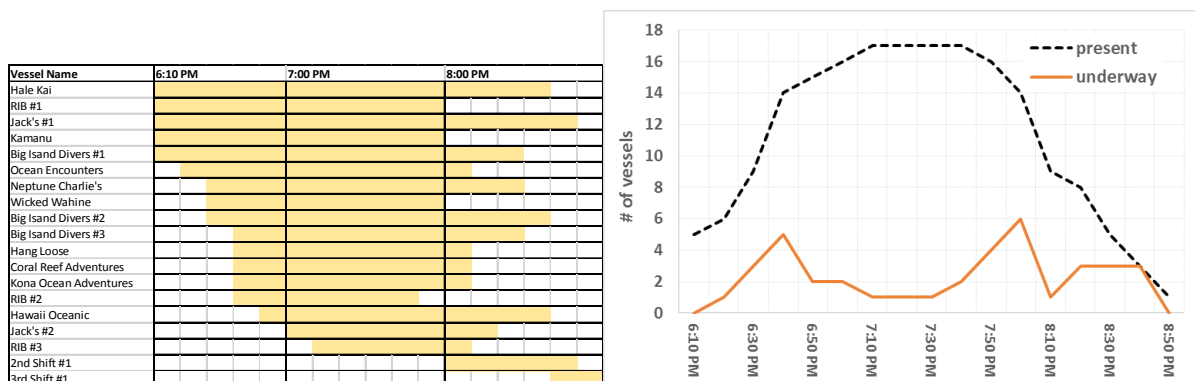
Figure 5. Time-motion statistics at Makako Bay on August 13, 2015 from 6:10-9:00 pm. Yellow bars indicate when each vessel, watercraft, or group was present at the manta viewing site. Each cell represents a 10 minute block of time. The beginning and end of each continuous yellow bar denotes when each vessel/group arrived and departed respectively. A nightly total of 19 vessels were observed with approximately 209 persons. During peak in-water activity 7:00-7:40 pm, most vessels were moored/anchored and relatively few were underway (i.e., actively motoring).

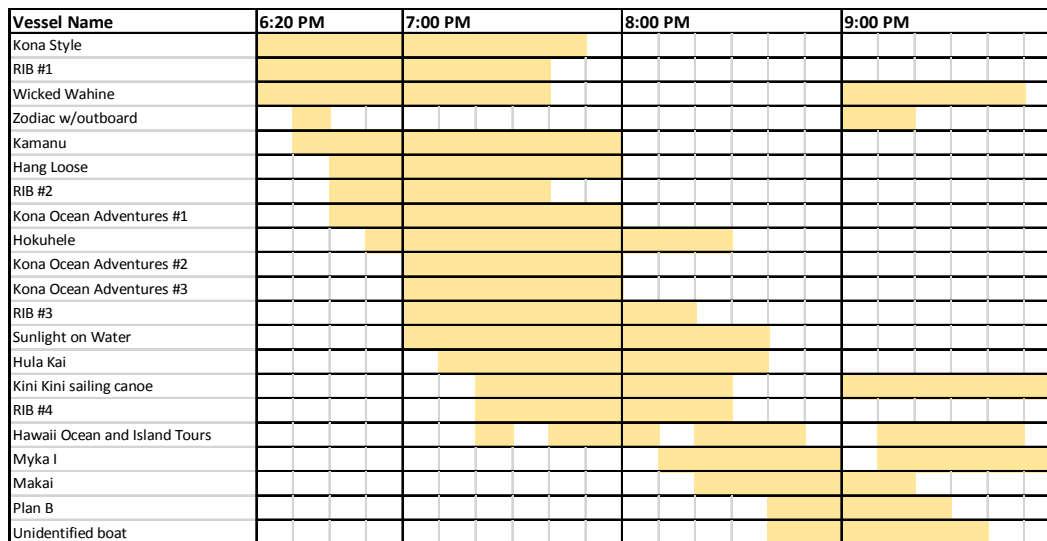
Figure 6. Time-motion chart at Keauhou Bay on Aug. 21, 2015 from 6:20-10:00 pm. Yellow bars indicate when each vessel, watercraft, or group was at the manta viewing site. Each cell represents a 10 minute block of time. The beginning and end of each continuous yellow bar denotes when each vessel/group arrived and departed respectively. Note that some vessels visit the site multiple times per night.

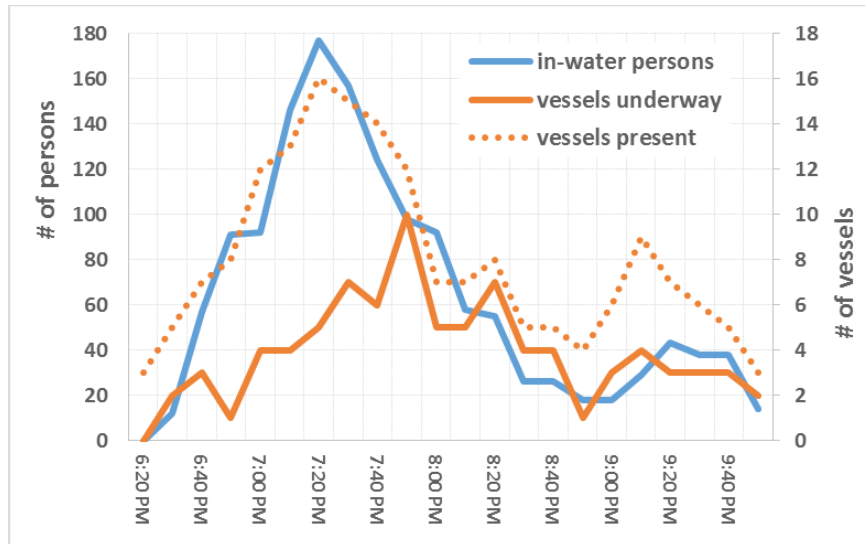
To help illustrate the overlap in boating activity with in-water snorkelers and divers, an intensive time & motion study was conducted on August 21, 2015 from 6:20-10:00 pm from the 2<sup>nd</sup> floor of the Sheraton Kona Resort. In addition to static totals (21 vessels, 6 kayaks, 1 SUP, and 301 persons), the arrival & departure and the live boating activity for each vessel was tracked across time along with the timing of persons entering and exiting the water from each vessel and from shore. Data was aggregated for each 10 minute block of time, where the number of in-water persons were quantified verses the number of vessels actively motoring at the site. Peak overlap occurred between 7:20-8:00 pm with 98-177 persons in the water while 5-10 vessels were actively motoring in the confined area ([Figure 6-7](#)).

Figure 7. Overlap between in-water persons and live boating activity (i.e., vessels underway) at the Keauhou Bay manta ray viewing site on August 21, 2015. A total of 21 vessels and 301 persons visited the site.
